APPENDIX C

Summaries of Existing Conditions and Management Recommendations for Subreaches of the North Branch of the Root River and Tributaries

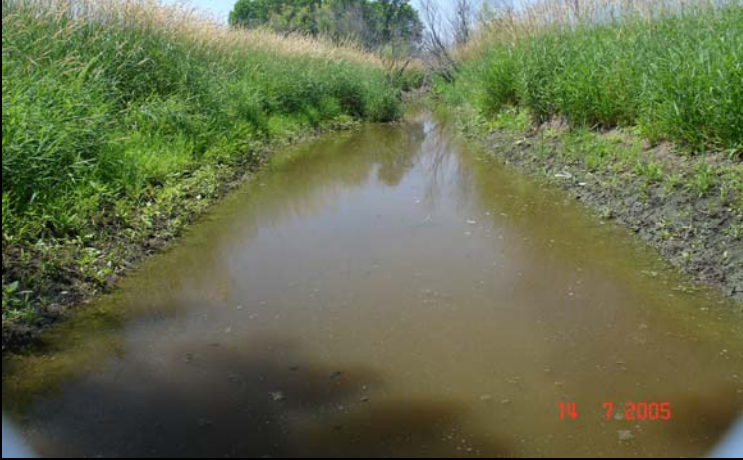
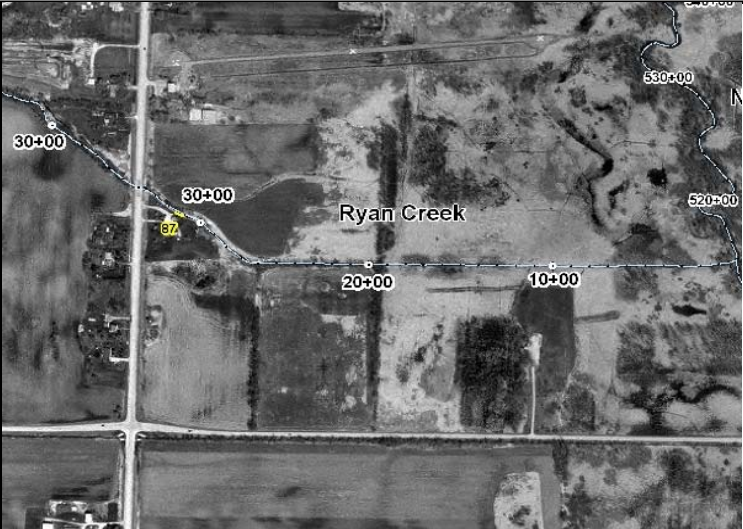
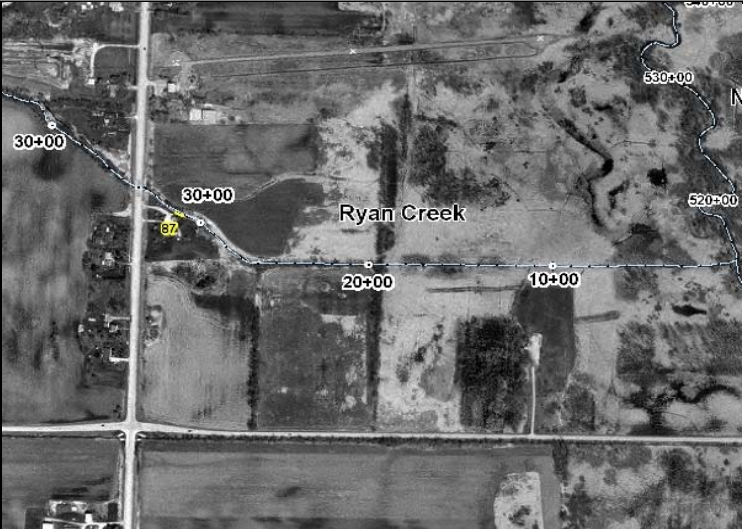
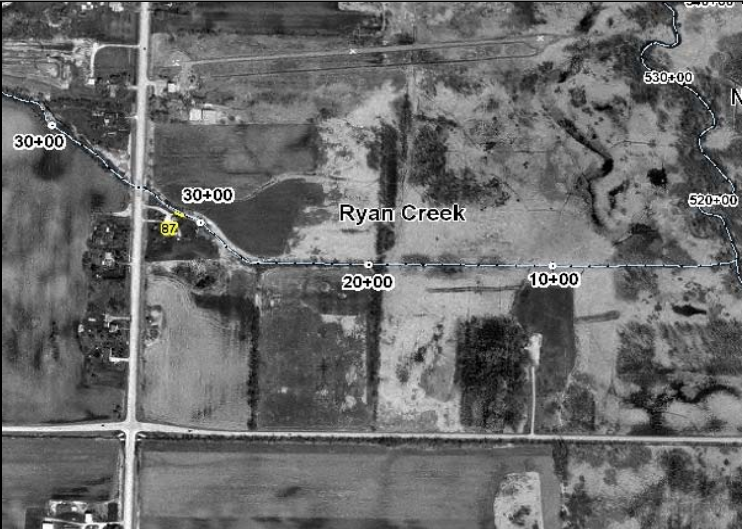
Figure C.20. Summary sheet for Ryan Creek.

Ryan Creek						
Upstream Limit: South 92nd Street Downstream Limit: Confluence with North Branch Root River			Upstream Station: 122+60 Downstream Station: 0+00			
Subreach Length: 2.3 miles (12,260 ft)

Hydrology Summary (at Mouth)						
<u>Mean Daily Flows</u> (Existing) (2020)						
90% Exceedence:	-	-				
50% Exceedence:	-	-				
10% Exceedence:	-	-				
5% Exceedence:	-	-				
1% Exceedence:	-	-				
<u>Instantaneous Peak Flows</u>						
2-year:	-	-				
5-year:	-	-				
10-year:	-	-				
25-year:	-	-				
50-year:	-	-				
100-year:	-	-				
Normal Depth Main Channel Hydraulics Summary (at mouth)						
Discharge:	<u>50% Exc.</u>	<u>10% Exc</u>	<u>1% Exc</u>	<u>2-year</u>	<u>10-year</u>	<u>100-year</u>
Hydraulic Depth:	-	-	-	-	-	-
Velocity:	-	-	-	-	-	-
Top Width:	-	-	-	-	-	-
Channel Capacity:	-	-	-	-	-	-
Geomorphic Characteristics

Bed Slope: 0.0037						
Bed Material: -						
Vertical Stability: Stable

Large Woody Debris: 0.9 per mile						
Total Bank Erosion: 0 ft (0%)						
Infrastructure

Storm Drain Outfalls: 0						
Grade-Control Struct: 0						
Bank Protection: 50 ft (0%)						
Road Crossings: 0						
Sediment-Transport Summary

<u>Average Annual</u> (Existing) (2020)						
Transport Capacity:	-	-				
Bed Material Supply:	-	-				
Agg/Deg Volume:	-	-				
Agg/Deg Depth:	-	-				
Primary Recommendations						
No action is recommended in Ryan Creek.						
Mussetter Engineering, Inc. Project #05-05 MMSD Contract # W30003P01			Root River Sediment-transport Planning Study
